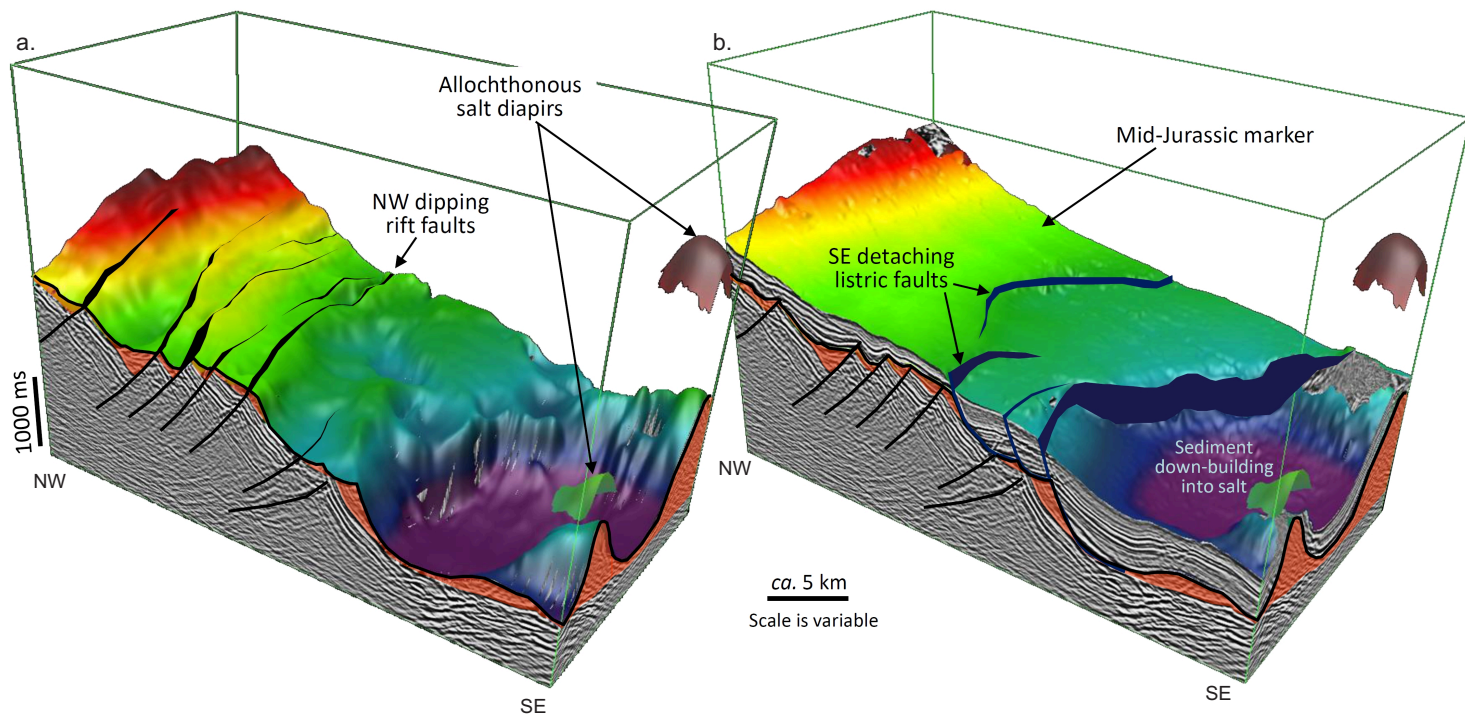
Figure 12 – a) Perspective view sculpted along the top autochthonous salt to primary weld marker, showing the synrift fabric below a thin veneer of autochthonous salt. The landward-dipping (northwest) extensional basement faults are well imaged; b) Perspective view showing a series of seaward dipping listric faults within Jurassic cover strata that sole out into the thin autochthonous salt layer. Fault vergence is in the opposite direction of the northwest-dipping synrift faults. See Figure 1a for location.
